Manhole Inspection Summary

Manhole # S35II_045MH

Location Address: **1500 LATROBE ST**

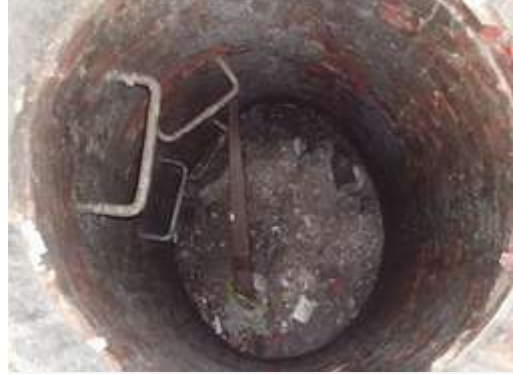
Top View

Channel debris.

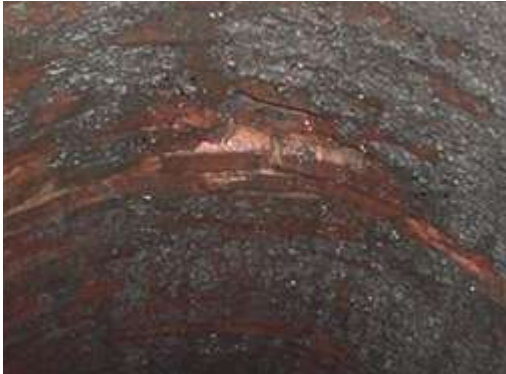
Defect

Corbel deterioration and infiltration.

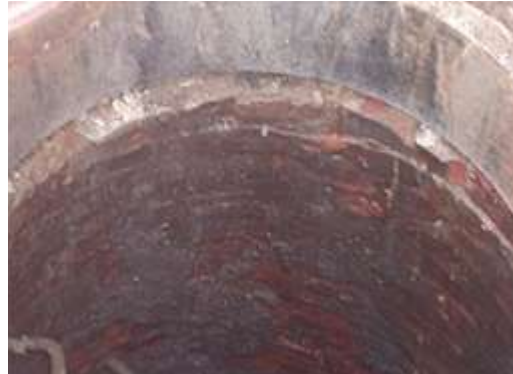
Defect

Frame leaks. Frame offset. Adjustment deterioration and infiltration.

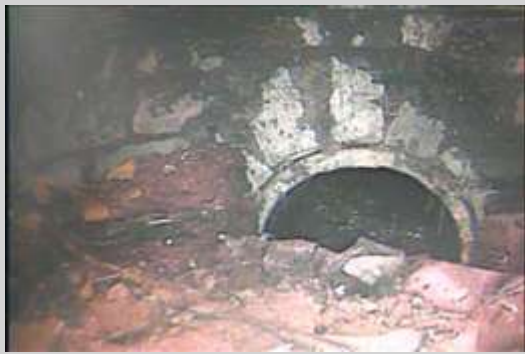
8 in. Circular Gravity Sewer
Pipe Out @ 12 O'Clock

Deposits: ☐ None ☒ **Mud** ☐ Sludge ☒ **Debris** ☐ Grease

Silt Depth: **2** (in.) Deposits Extent: **Medium**
